Characterisation of fatigue damage in composites using an Acoustic Emission
Parameter Correction Technique

Safaa Kh Al-Jumaili, Mark J. Eaton, Karen M. Holford, Matthew R. Pearson, Davide
Crivelli, Rhys Pullin

Characterisation of Fatigue Damage in Composites Using an Acoustic Emission Parameter Correction Technique

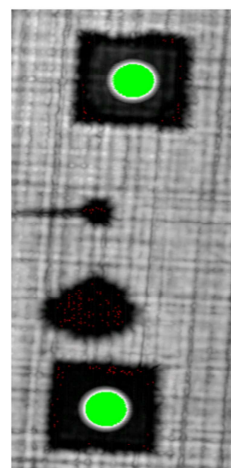
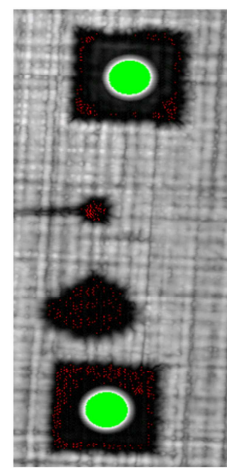
The C-scan images are shown in Figure 5 and reveal the different conditions of the panel during the test. After manufacturing, the C-scan image shows there is no internal damage (Figure 5a). After applying the first 26 loading batches (ending with 21 kN load after 130k cycles) the panel is still without any signs of

internal damage (Figure 5b). The artificial crack location indicates a very slightly higher attenuation, but it is difficult to identify in-plane cracking by C-scan inspection so this cannot be considered conclusive. After impact (Figure 5c), a clear region of high attenuation is observed just above the lower tab indicating the location of impact induced delamination. The dark spot seen centrally in all the images is sensor 5 with its cable exiting to the left of the image also visible. At the end of the test (31 kN load after 285k cycles) no discernible growth in the delamination area can be observed, suggesting that the delamination has not grown during the test (Figure 5d). Again a mild increase in attenuation at the cut plies (just below sensor 5) is observable in Figure 5d but no positive indication of matrix crack growth can be inferred from this.
